CASE REPORT

Repair Protocol of Porcelain Laminate Veneers Through Reattachment of the Fractured Ceramic Piece: A Technical Report

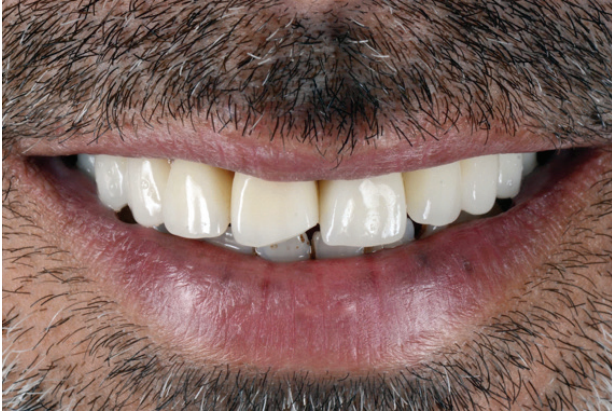
A 35-year-old male patient was applied to the clinic with a fracture on the mesial incisal edge of lithium disilicate crown restoration in tooth number 11. The patient also brought the entire fractured piece. It was decided to cement the entire fractured piece to the restoration with adhesive system instead of replacing this restoration.

Figure 1 - Frontal view of porcelain laminate veneer fracture.

1. If there is a sharp pointed places in the fractured area in the ceramic surface

(Figure 1), smooth these places with diamond bur with low speed handpiece.

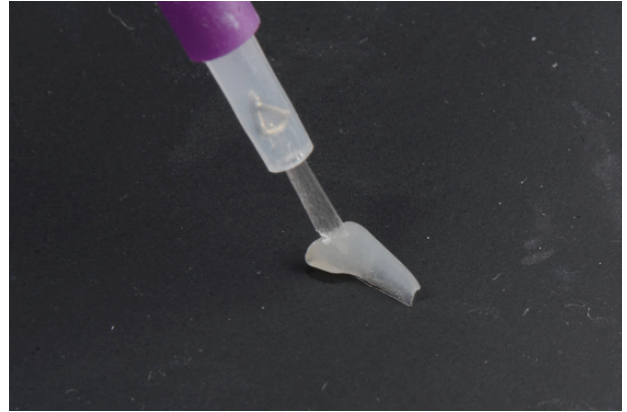
Figure 4 - Application of silane coupling agent and waiting for its reaction for 1 min.

4. Apply silane coupling agent (Monobond S, Ivoclar Vivadent) to fractured piece of laminate veneer and allowed to react 1 min (Figure 4).

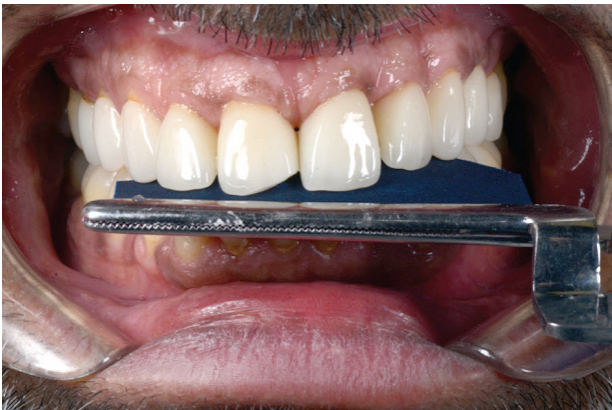
Figure 2 - Occlusion control for presence of any premature contact at the level of the fracture line with articulating paper.

2. Check the presence of any contact at the level of the fracture line with the articulating paper (Bausch Articulating Paper, Dr. Jean Bausch GmbH & Co. KG) (Figure 2).

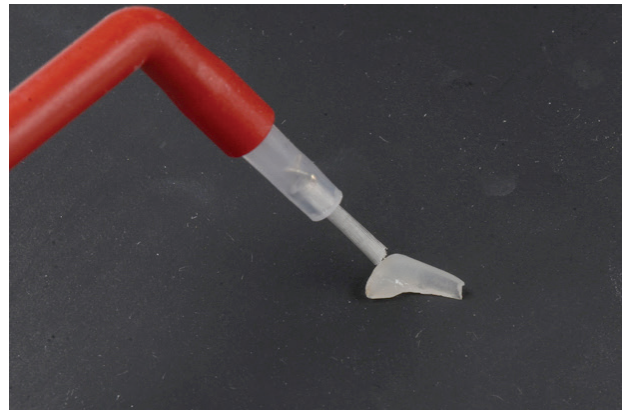
Figure 5 - Application of light curing bonding agent.

5. Apply a thin layer of light curing bonding agent (Heliobond, Ivoclar Vivadent) to fractured piece of laminate veneer (Figure 5).

Remove any excess with compressed air.

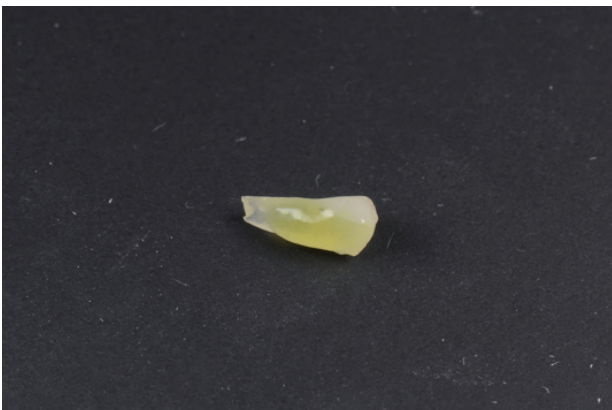
Figure 3 - Etching fractured piece of porcelain laminate veneer with 4% hydrofluoric acid for 1 min.

3. Apply 4% hydrofluoric acid (Porcelain Etchant, Bisco) for 1 min to fractured piece of the laminate veneer (Figure 3). Then wash for 1 min and dry with oil free compressed air.

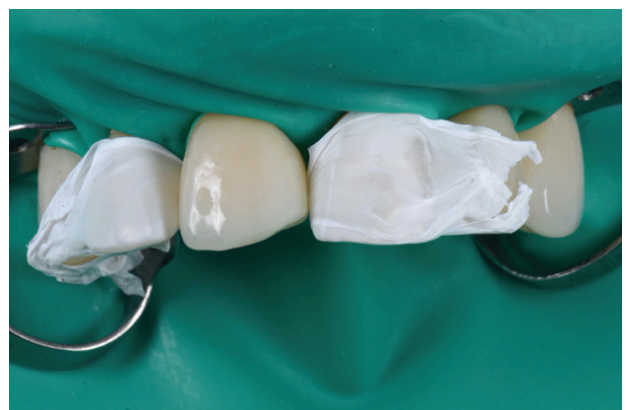
Figure 6 - Isolation with rubberdam and polytetrafluoroethylene tape.

6. Isolate the teeth with rubberdam (Roeko Dental Dam, Coltene). Also cover right upper lateral incisor and left upper central incisor with polytetrafluoroethylene tape (Figure 6).

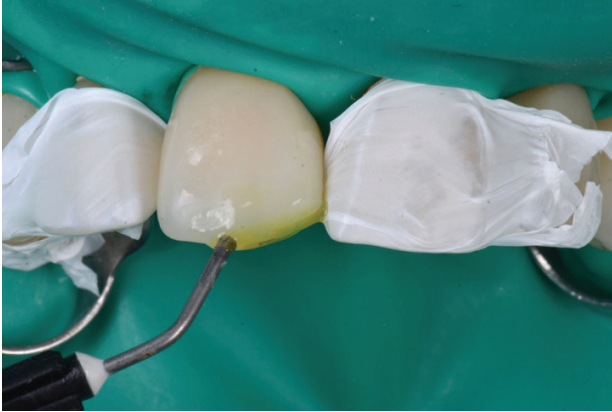
Figure 7 - Fractured ceramic area etching with 4% hydrofluoric acid for 1 min.

8. Apply 4% hydrofluoric acid (Porcelain Etchant, Bisco) for 1 min to fractured area in the tooth (Figure 7). Then wash for 1 min and dry with oil free compressed air.

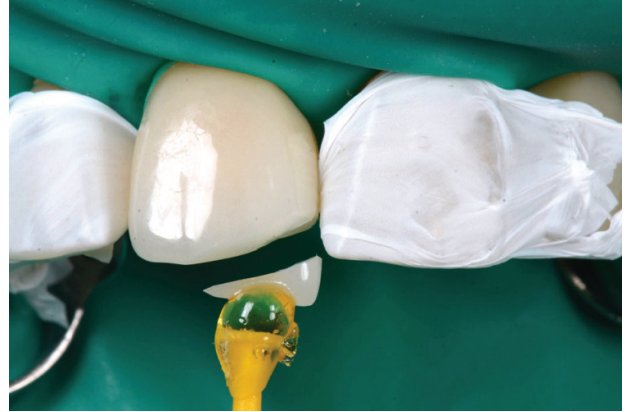
Figure 10 - Bonding the fractured piece of porcelain laminate veneer to ceramic area on the teeth.

11. Apply resin cement (Variolink N LC, Ivoclar Vivadent) to fractured piece of laminate veneer inner surface (Figure 10).

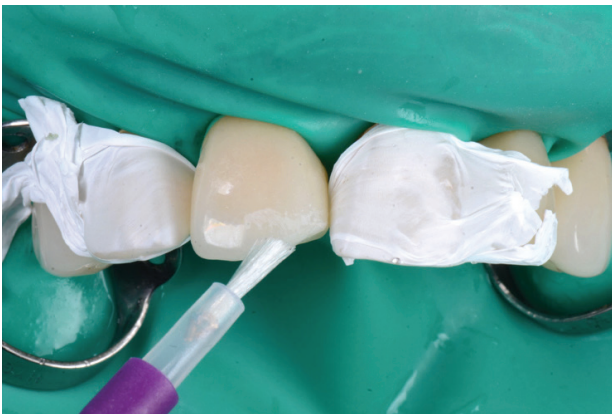
Figure 8 - Application of silane coupling agent and waiting for its reaction for 1 min.

9. Apply silane coupling agent (Monobond S, Ivoclar Vivadent) to fractured area on the teeth and allowed to react 1 min (Figure 8).

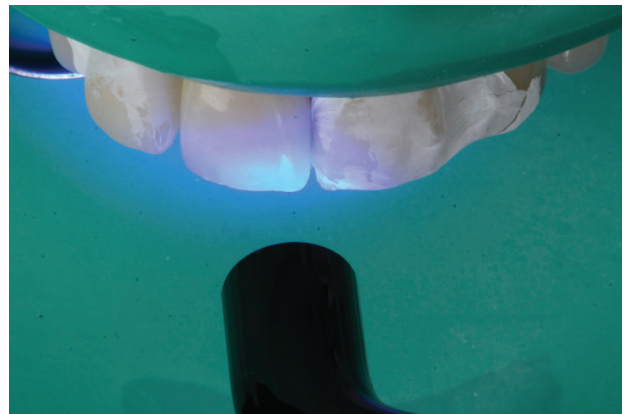
Figure 11 - Photo-polymerization of the light-cure adhesive resin cement.

12. After placement of the piece of laminate veneer, apply to light (Bluephase, Ivoclar Vivadent) labial surface of the laminate veneer for 40 s (Figure 11). The light have to be at least 800 mW/cm².

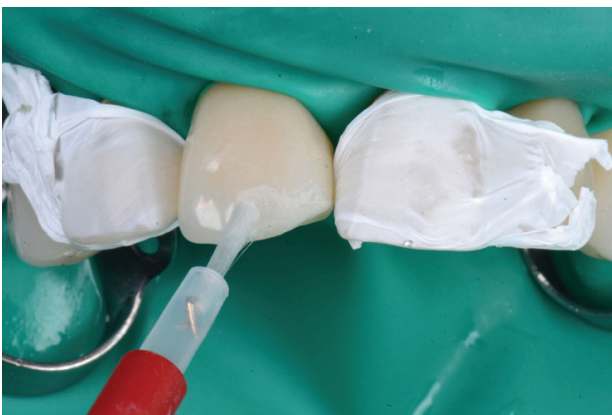
Figure 9 - Application of light curing bonding agent.

10. Apply a thin layer of light curing bonding agent (Heliobond, Ivoclar Vivadent) to the entire surface area which needs to be repaired. Remove any excess with compressed air (Figure 9).

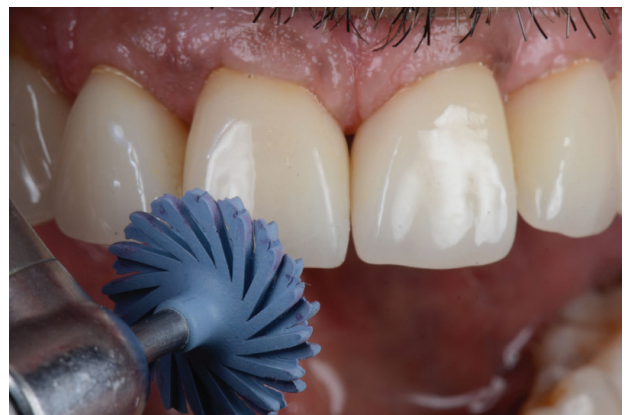
Figure 12 - Finishing and polishing of the porcelain laminate veneer.

15. Polish fractured line with silicone polishers (EVE Diapol Twist, Ernst Vetter GmbH) under water (Figure 12). If you need you can use interproximal polishing strip.

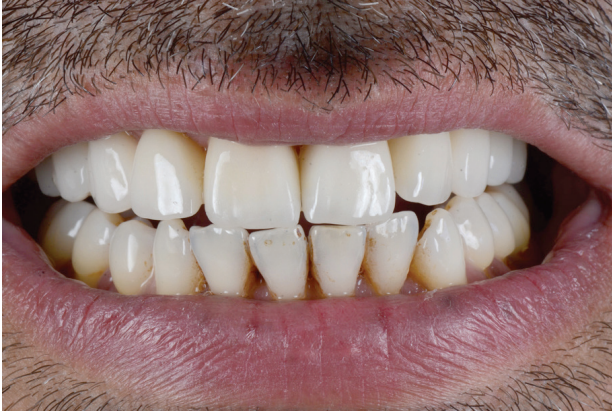
Figure 13 - Occlusion control during anterior movement.

16. At the end, check the contacts in centric occlusion, lateral and protrusive movements of the jaw (Figure 13).

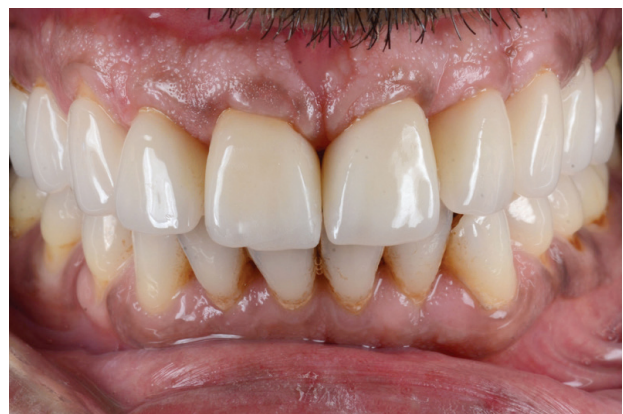
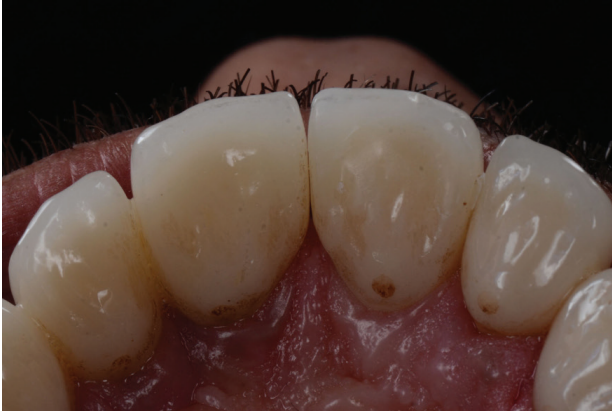
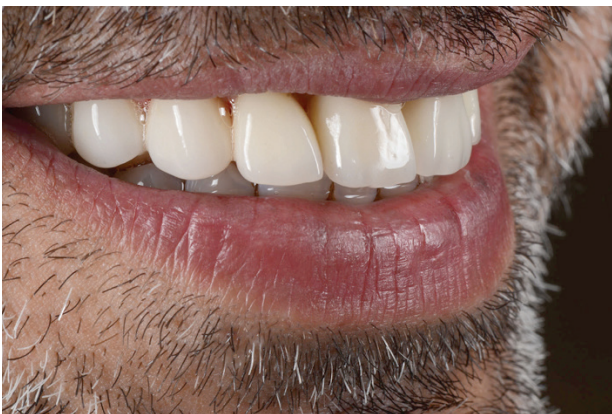
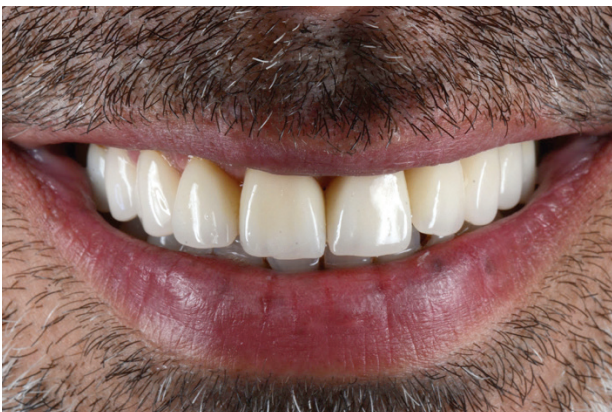
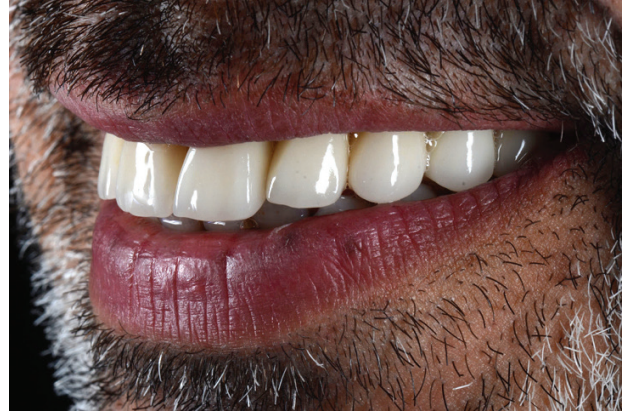
In the previous technique, fractured parts were repaired with composite restorations [22]. Discoloration and compatibility with porcelain surface are disadvantages of repairing with composite. The advantage of this technique is the repair of a lamina veneer with own piece. It seems extremely one-piece, because it is cemented with its own part (Figure 14-18).

Figure 14 - Intraoral frontal view of bonded porcelain laminate veneer.

Figure 15 - Palatal view of bonding area.

Figure 18 - Left lateral view of bonded porcelain laminate veneer.

Figure 16 - Right lateral view of bonded porcelain laminate veneer.

Figure 17 - Frontal view of bonded porcelain laminate veneer.

In present case, which was repaired with its own part, no failure was observed during 3 years clinical follow-up.
