## Association of custom-made zirconia abutments with emax crowns in implant rehabilitations: case report

In this sense the aim of this study was to demonstrate through case report the applicability of custom-made zirconia abutments in association with IPS eMax metal-free crowns.

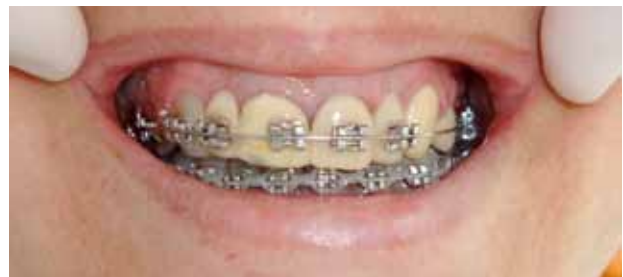
Figure 1 - Initial case

Patient ACS, female, Caucasian, aging 41 years-old was referred to evaluation of a partial fixed veneer crown between teeth #12 and #23. The left permanent maxillary central incisor (#21) exhibited a root fracture and it was extracted. The left permanent maxillary first premolar (#24) had a single veneer crown. The patient was at orthodontic finalization stage (figure 1) with later removal of old prosthesis (figure 2).

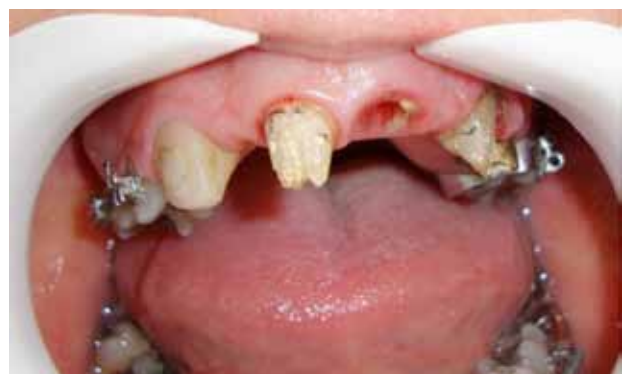
Figure 2 - Clinical view after the removal of old prostheses

Because of both the aesthetic dissatisfaction and the functional impairment due to root crack and infiltration, the treatment planning comprised the removal of the old prostheses, extraction of tooth #21 and the installation of 3 implants (Sin – Sistema de Implantes, São Paulo, Brazil), on the areas of teeth #12 (3.5 x 13 mm cone Morse), #21 (IH 3.8 x 13 mm) and 22 (3.8 x 13mm).

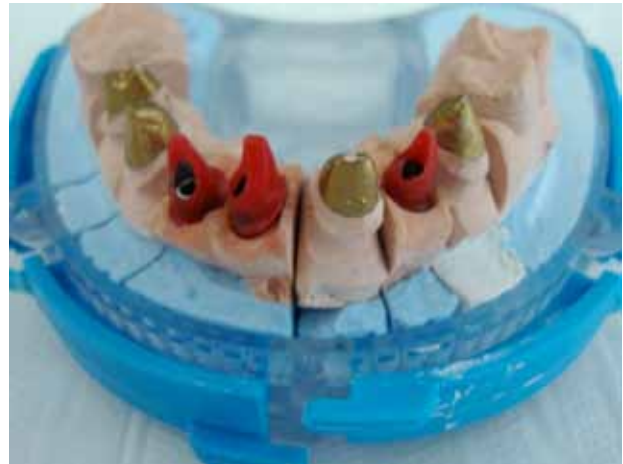
**Figure 3** - View of the functional cast and custom-made resin abutments.

Next, a transfer impression was executed comprising the prepared teeth and implants; the abutments were customized firstly in acrylic resin (figure 3) for trial and then in zirconia through Ceramill Map 400 CAD/ Milling Motion 2 CAM (AmannGirrbach Ltda, Curitiba, Brazil) (figure 4).

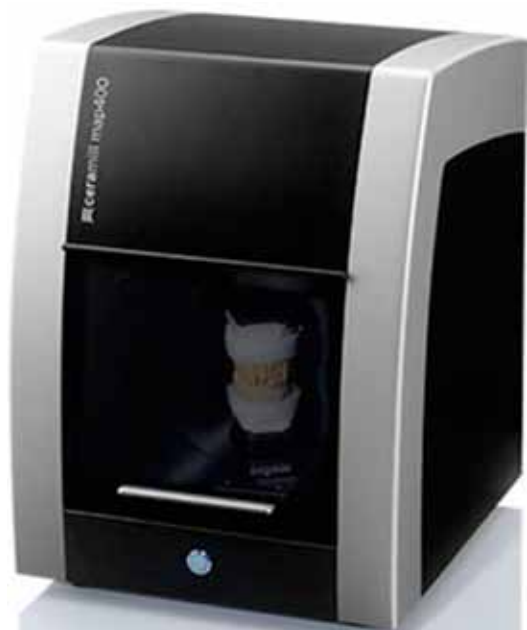
**Figure 4** - View of CAD/CAM system.

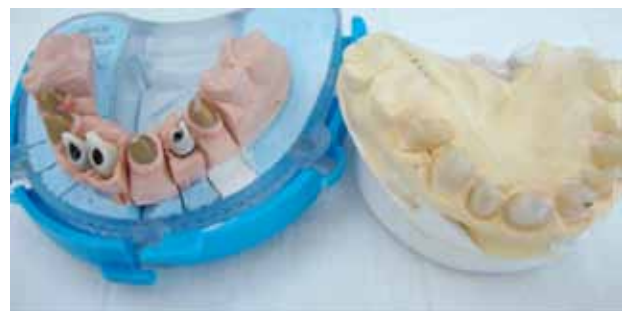
**Figure 5** - View of transfer casts and functional cast with zirconia copings.

After the new trial in the mouth, the copings were constructed through IPS eMax Press system (Ivoclar Vivadent Ltda, Barueri, SP, Brazil), which after new trials and adjustments were transferred through another impression (figure 5).

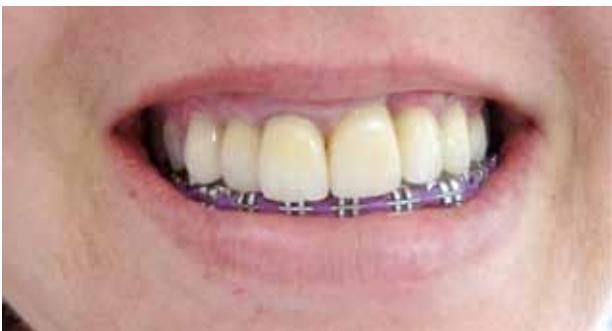
**Figure 6** - View of the case conclusion after cementation.

The crowns were cleaned with aluminum oxide ( $Al_2O_3$ ) with 1 bar pressure and silanized by 60 s. Then the crowns were cemented with self-etching resin cement (RelyX U100, 3M ESPE/ Sta Paul, MN, USA) (figure 6) without conditioning dental surface.

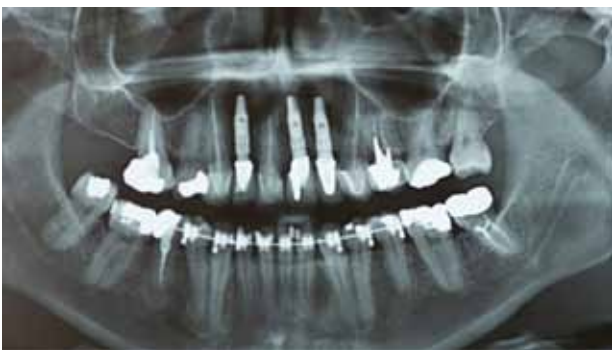
**Figure 7** - Follow-up radiographic after 90 days.

Patient was followed-up at 7, 15, 30, 60 and 90 days, and after that, a new follow-up radiographic was taken (figure 7).
